Magnesia FGD Process Testing on a Coal-Fired Power Plant

York Research Corp, Stamford, Conn

EPA-600/2-77-165
August 1977

1. REPORT NO. EPA-600/2-77-165		3. RECIPIENT'S ACCESSION NO. PB272952	
4. TITLE AND SUBTITLE Magnesia FGD Process Testing on a Coal-Fired Power Plant		5. REPORT DATE August 1977

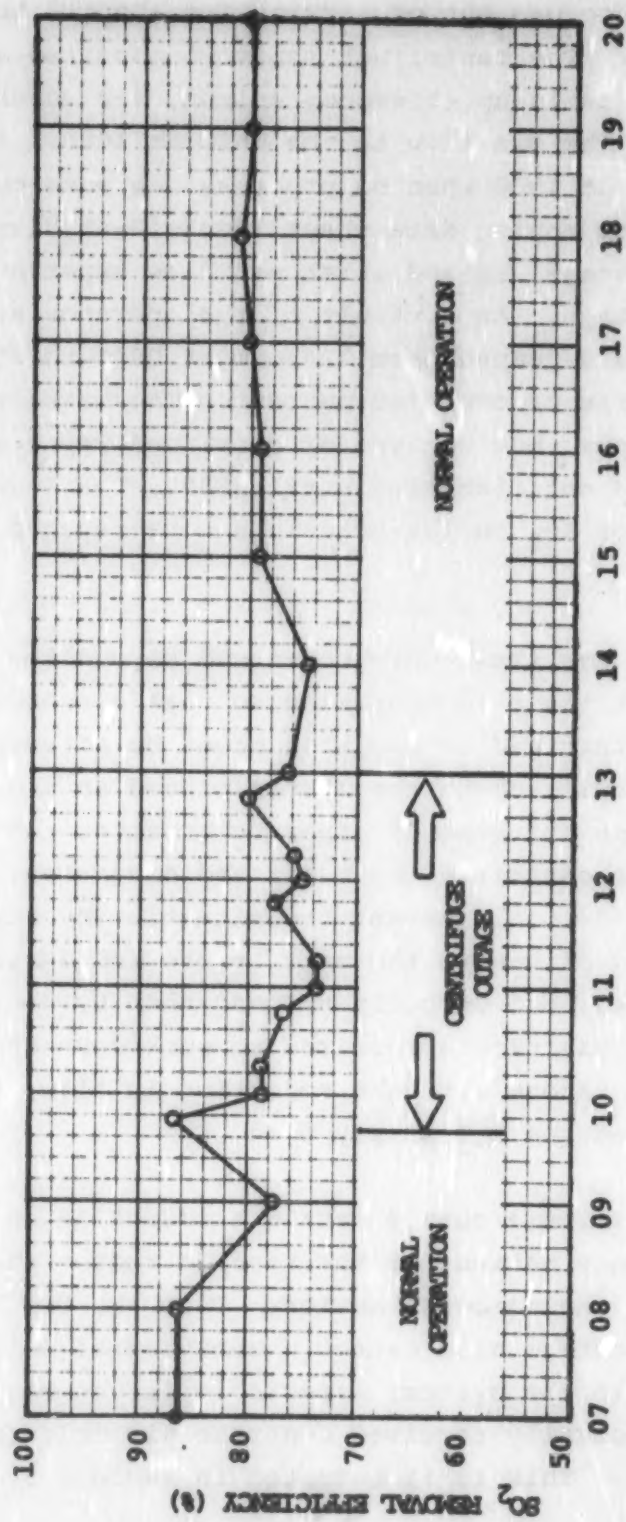
6.1.5 Solids Removal Section for the Second Stage

Centrifuge cover leaks and clogging of the centrifuge chute were the major problems with this equipment throughout the test program. The leaks in the cover were probably caused by the abrasive material in the centrifuge feed water which wore away the carbon steel. The centrifuge chute required almost continual attention at times, depending on the consistency of the centrifuge cake. On days when the cake was wet or sticky, the chute would require periodic cleaning during each shift in order to prevent clogging. The angle of the chute was changed once during the program and the vibrators were adjusted for continual operation but these changes had little effect on the clogging problem. As the test program progressed, The operators started to wash the chute on a regular basis during their shift to prevent this problem. Using a different configuration or type of equipment may eliminate these problems in future designs.
